# EASTERN SYRIA FLASH FLOODS

Humanitarian impact, damaged infrastructure and access constraints

27-29 OCTOBER 2026

**EMISSA | Field Monitoring & Assessment Unit**

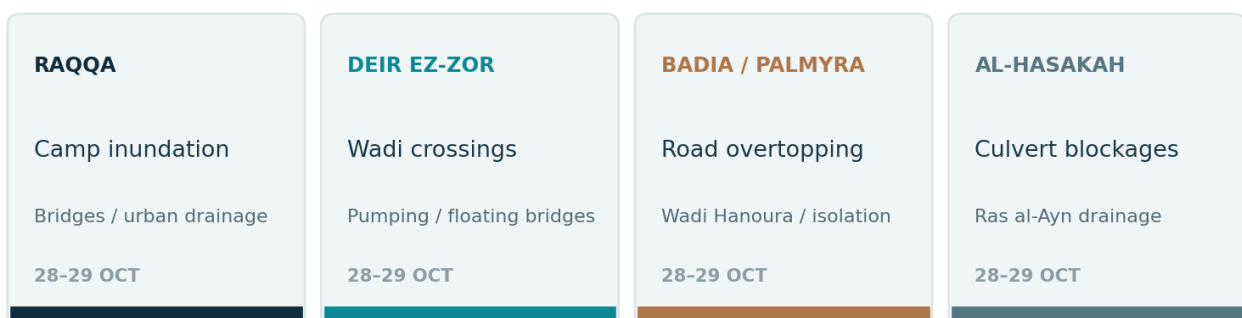
Figure 4. Distinct exposure patterns across the October flash-flood footprint. The cards classify reported effects and operational risks, not a comparative severity ranking.
